Partial Discharge Signals Switchgear Condition

By Paul Shiel, ESB Networks, Ireland

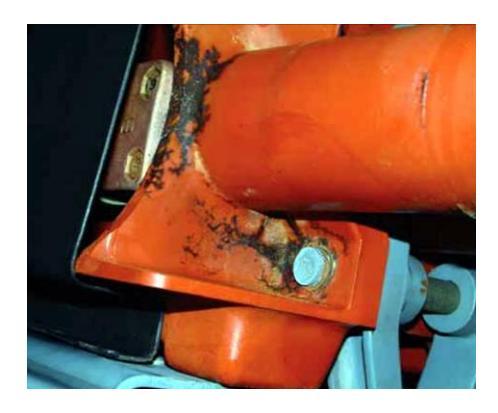
Internal inspections revealed evidence of PD activity in the switchgear installed in the three substations where the sensitive ultrasonic equipment identified PD activity. The area affected was the fixed copper contacts that exhibited verdigris growth with some resulting acid damage contributing to early stages on insulation degradation. The findings confirmed PD activity that ultimately could result in switchgear failure. Although difficult to estimate, consensus was that failure of these three units was unlikely to occur within 12 months. For these substations, the operational restrictions remained in place until maintenance or replacement was performed.

Example of surface partial discharge activity

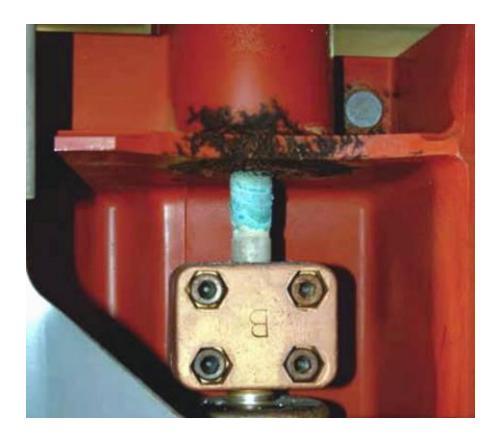
Example of surface tracking

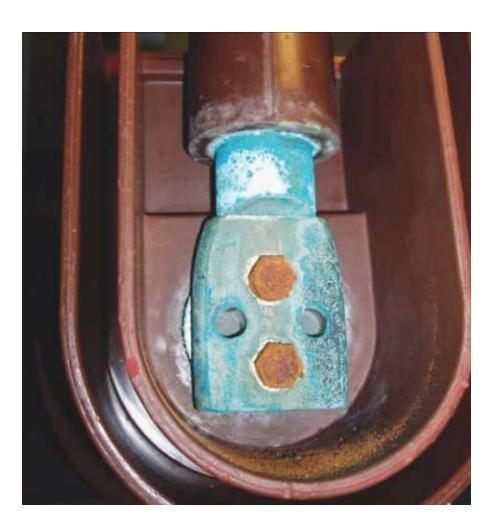
Example of verdigris growth
